Flood Control Project Maintenance
2015 Structure Summary Report
Overall Unit and Item Ratings

DWR Sutter Maintenance Yard

Butte Slough Drainage Structure

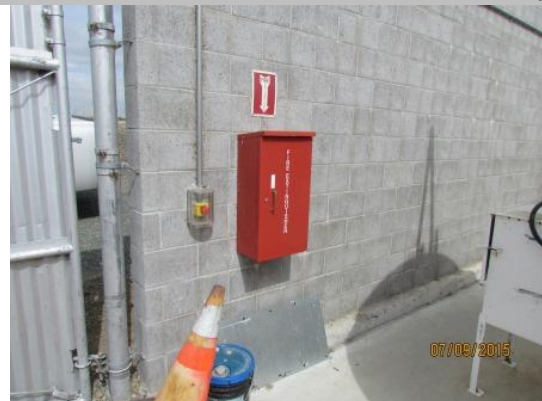
Photo 1 of 1 : ST_2015_NA0060_22_5_20150720_00018.jpg

LM Start	0.00	Rating **	A	Issue No.	5
LM End	0.00	Issue Type +	Ma	Location *	
Category	Pump Stations			GPS Latitude/Longitude	
				Start	End
Item	Safety			39.026449 °	39.026449 °
				-121.726937 °	-121.726937 °
DWR ID	DWR_NA0060_22_t_2012_5				
Action/Comments					
Inspector Comments: Site is under construction safety wear is required during construction (hard hat, vest and eyewear). Some of the hazards may include moving equipment.

View of the emergency shutoff switch and fire extinguisher.

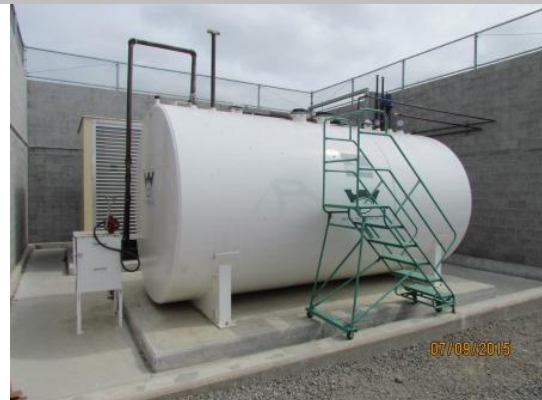
Photo 1 of 2 : ST_2015_NA0060_22_8_20150720_00019.jpg

LM Start	0.00	Rating **	A	Issue No.	8
LM End	0.00	Issue Type +	Ma	Location *	
Category	Pump Stations			GPS Latitude/Longitude	
				Start	End
Item	Power			39.026449 °	39.026449 °
				-121.726937 °	-121.726937 °
DWR ID	DWR_NA0060_22_t_2012_8				
Action/Comments					
Inspector Comments: The structure is on the grid with emergency backup generator.

View of the emergency backup generator fuel tank.

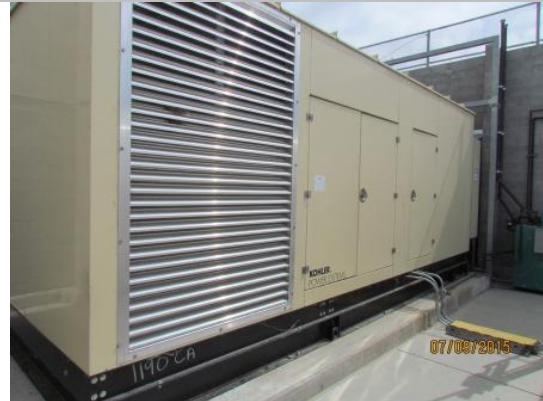
Photo 2 of 2 : ST_2015_NA0060_22_8_20150720_00020.jpg

LM Start	0.00	Rating **	A	Issue No.	8 (cont)	
LM End	0.00	Issue Type +	Ma	Location *		
Category	Pump Stations			GPS Latitude/Longitude		
				Start	End	
Item	Power			39.026449 °	39.026449 °	
				-121.726937 °	-121.726937 °	
DWR ID	DWR_NA0060_22_t_2012_8					
Action/Comments						
Inspector Comments: The structure is on the grid with emergency backup generator.

View of the emergency backup generator.

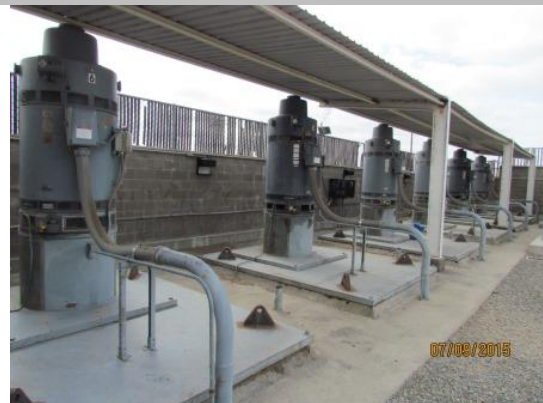
Photo 1 of 1 : ST_2015_NA0060_22_10_20150720_00021.jpg

LM Start	0.00	Rating **	A	Issue No.	10
LM End	0.00	Issue Type +	Ma	Location *	
Category	Pump Stations			GPS Latitude/Longitude	
				Start	End
Item	Motors, Engines, Fans & Gear Reducers			39.026449 °	39.026449 °
				-121.726937 °	-121.726937 °
DWR ID	DWR_NA0060_22_t_2012_10				
Action/Comments					
Inspector Comments: These items appear to be maintained and in operating condition.

View of the pump motors.

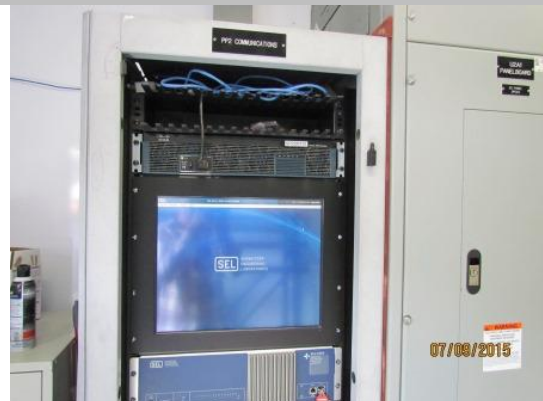
Photo 1 of 2 : ST_2015_NA0060_22_11_20150720_00022.jpg

LM Start	0.00	Rating **	A	Issue No.	11	
LM End	0.00	Issue Type +	Ma	Location *		
Category	Pump Stations			GPS Latitude/Longitude		
				Start	End	
Item	Pump Control Systems			39.026449 °	39.026449 °	
				-121.726937 °	-121.726937 °	
DWR ID	DWR_NA0060_22_t_2012_11					
Action/Comments						
Inspector Comments: Pump control systems on site are new and appear to be in working order.

View of the pump control computer.

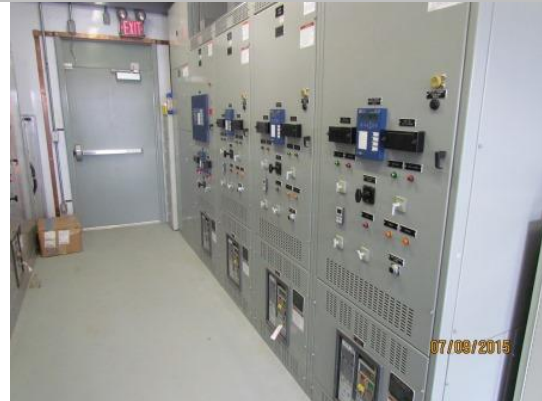
Photo 2 of 2 : ST_2015_NA0060_22_11_20150720_00023.jpg

LM Start	0.00	Rating **	A	Issue No.	11 (cont)	
LM End	0.00	Issue Type +	Ma	Location *		
Category	Pump Stations			GPS Latitude/Longitude		
				Start	End	
Item	Pump Control Systems			39.026449 °	39.026449 °	
				-121.726937 °	-121.726937 °	
DWR ID	DWR_NA0060_22_t_2012_11					
Action/Comments						
Inspector Comments: Pump control systems on site are new and appear to be in working order.

View of the manual electrical pump controls.

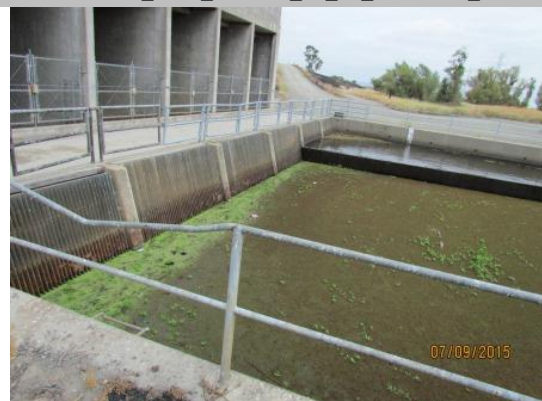
Photo 1 of 1 : ST_2015_NA0060_22_13_20150720_00024.jpg

LM Start	0.00	Rating **	A	Issue No.	13	
LM End	0.00	Issue Type +	Ma	Location *		
Category	Pump Stations			GPS Latitude/Longitude		
				Start	End	
Item	Trash Racks			39.026449 °	39.026449 °	
				-121.726937 °	-121.726937 °	
DWR ID	DWR_NA0060_22_t_2012_13					
Action/Comments						
Inspector Comments: Trash rack is secure and free of debris.

View of the trash racks.

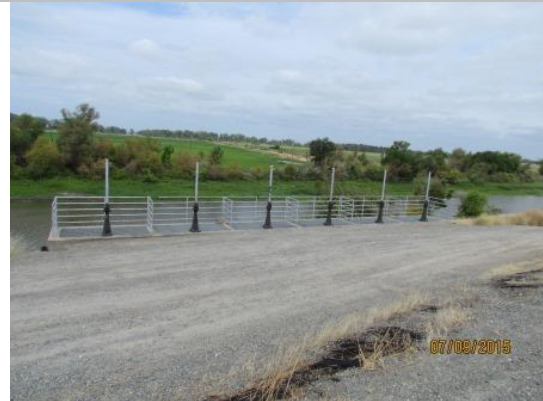
Photo 1 of 1 : ST_2015_NA0060_22_17_20150720_00025.jpg

LM Start	0.00	Rating **	A	Issue No.	17
LM End	0.00	Issue Type +	Ma	Location *	
Category	Pump Stations			GPS Latitude/Longitude	
				Start	End
Item	Manual Gate Operators			39.026449 °	39.026449 °
				-121.726937 °	-121.726937 °
DWR ID	DWR_NA0060_22_t_2012_17				
Action/Comments					
Inspector Comments: Manual gate operators appear to be in good working condition.

Photo shows controls for sluice gates.

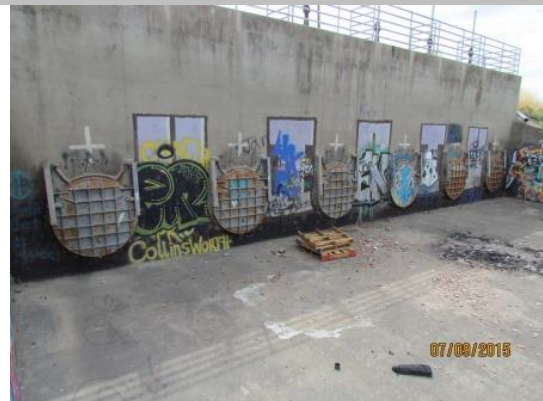
Photo 1 of 1 : ST_2015_NA0060_22_19_20150720_00028.jpg

LM Start	0.00	Rating **	A	Issue No.	19	
LM End	0.00	Issue Type +	Ma	Location *		
Category	Pump Stations			GPS Latitude/Longitude		
				Start	End	
Item	Flap Gates			39.026449 °	39.026449 °	
				-121.726937 °	-121.726937 °	
DWR ID	DWR_NA0060_22_t_2012_19					
Action/Comments						
Inspector Comments: Flap gates are in proper working condition, they show no signs of corrosion or damage.

View of the flap gates.

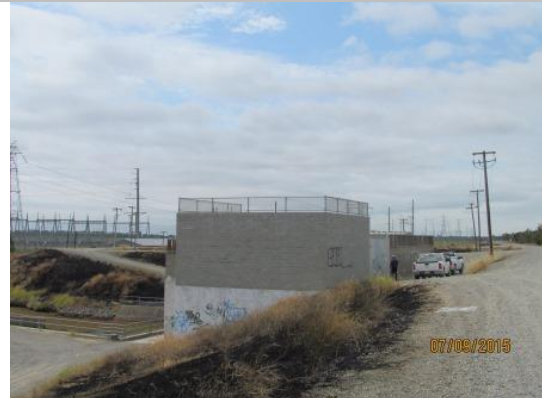
Photo 1 of 1 : ST_2015_NA0060_22_21_20150720_00029.jpg

LM Start	0.00	Rating **	A	Issue No.	21
LM End	0.00	Issue Type +	Ma	Location *	
Category	Pump Stations			GPS Latitude/Longitude	
				Start	End
Item	Security Fencing			39.026449 °	39.026449 °
				-121.726937 °	-121.726937 °
DWR ID	DWR_NA0060_22_t_2012_21				
Action/Comments					
Inspector Comments: Site is currently secured by a masonry brick wall.

Photo shows masonry block wall which encloses the site.

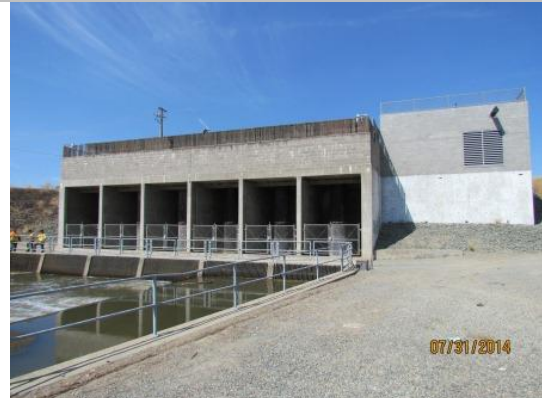
Photo 1 of 2 : ST_2015_NA0060_22_22_20150709_00014.jpg

LM Start	0.00	Rating **	A	Issue No.	22
LM End	0.00	Issue Type +	Ma	Location *	
Category	Pump Stations			GPS Latitude/Longitude	
				Start	End
Item	Intake and Discharge Pipes			39.026449 °	39.026449 °
				-121.726937 °	-121.726937 °
DWR ID	DWR_NA0060_22_t_2012_22				
Action/Comments					
Inspector Comments: No visible deficiencies observed in the pipe's condition.

View of the intake structure.

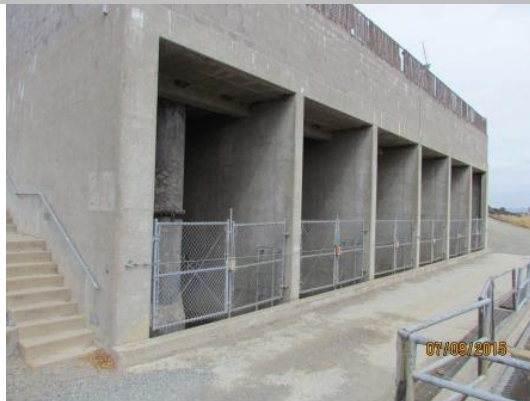
Photo 2 of 2 : ST_2015_NA0060_22_22_20150720_00030.jpg

LM Start	0.00	Rating **	A	Issue No.	22 (cont)	
LM End	0.00	Issue Type +	Ma	Location *		
Category	Pump Stations			GPS Latitude/Longitude		
				Start	End	
Item	Intake and Discharge Pipes			39.026449 °	39.026449 °	
				-121.726937 °	-121.726937 °	
DWR ID	DWR_NA0060_22_t_2012_22					
Action/Comments						
Inspector Comments: No visible deficiencies observed in the pipe's condition.

Closer view of the sump wells.

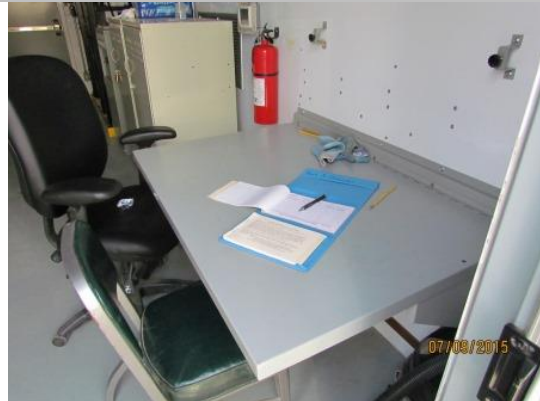
Photo 1 of 1 : ST_2015_NA0060_23_1_20150720_00013.jpg

LM Start	0.00	Rating **	A	Issue No.	1
LM End	0.00	Issue Type +	Ma	Location *	
Category	Pump Stations			GPS Latitude/Longitude	
				Start	End
Item	Operating Log			39.120096 °	39.120096 °
				-121.779234 °	-121.779234 °
DWR ID	DWR_NA0060_23_t_2012_1				
Action/Comments					
Inspector Comments: Operation log is at the site.

View of the Operating Log.

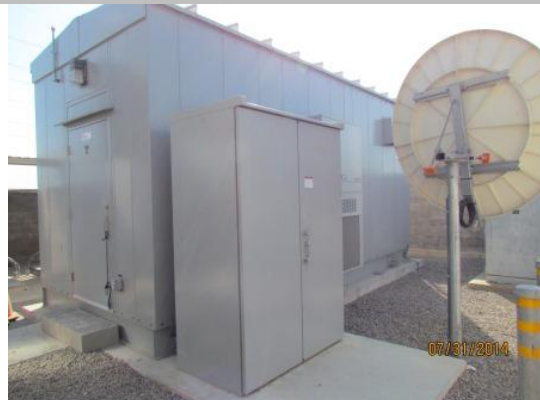
Photo 1 of 1 : ST_2015_NA0060_23_3_20150709_00002.jpg

LM Start	0.00	Rating **	A	Issue No.	3
LM End	0.00	Issue Type +	Ma	Location *	
Category	Pump Stations			GPS Latitude/Longitude	
				Start	End
Item	Plant Building			39.120096 °	39.120096 °
				-121.779230 °	-121.779230 °
DWR ID	DWR_NA0060_23_t_2012_3				
Action/Comments					
Inspector Comments: Plant building appears to be in good working condition. The project is currently under construction.

View of the Plant control building.

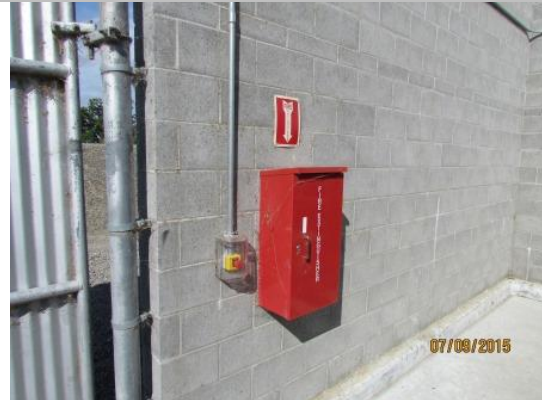
Photo 1 of 1 : ST_2015_NA0060_23_5_20150720_00014.jpg

LM Start	0.00	Rating **	A	Issue No.	5
LM End	0.00	Issue Type +	Ma	Location *	
Category	Pump Stations			GPS Latitude/Longitude	
				Start	End
Item	Safety			39.120096 °	39.120096 °
				-121.779230 °	-121.779230 °
DWR ID	DWR_NA0060_23_t_2012_5				
Action/Comments					
Inspector Comments: Site is under construction safety wear is required during construction (hard hat, vest and eyewear). Some of the hazards may include moving equipment.

View of the fire extinguisher and emergency shut off.

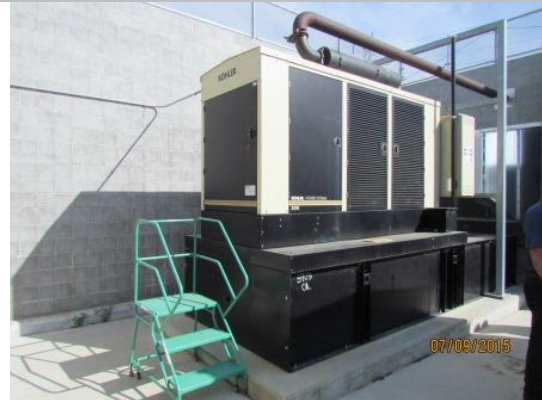
Photo 1 of 1 : ST_2015_NA0060_23_8_20150720_00015.jpg

LM Start	0.00	Rating **	A	Issue No.	8
LM End	0.00	Issue Type +	Ma	Location *	
Category	Pump Stations			GPS Latitude/Longitude	
				Start	End
Item	Power			39.120096 °	39.120096 °
				-121.779230 °	-121.779230 °
DWR ID	DWR_NA0060_23_t_2012_8				
Action/Comments					
Inspector Comments: The structure is on the grid with emergency generator backup.

View of the emergency backup generator.

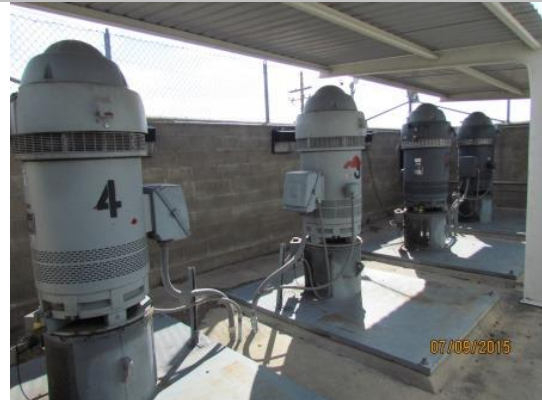
Photo 1 of 1 : ST_2015_NA0060_23_10_20150720_00016.jpg

LM Start	0.00	Rating **	A	Issue No.	10
LM End	0.00	Issue Type +	Ma	Location *	
Category	Pump Stations			GPS Latitude/Longitude	
				Start	End
Item	Motors, Engines, Fans & Gear Reducers			39.120096 °	39.120096 °
				-121.779230 °	-121.779230 °
DWR ID	DWR_NA0060_23_t_2012_10				
Action/Comments					
Inspector Comments: These items appear to be maintained and in operating condition.

View of the motors.

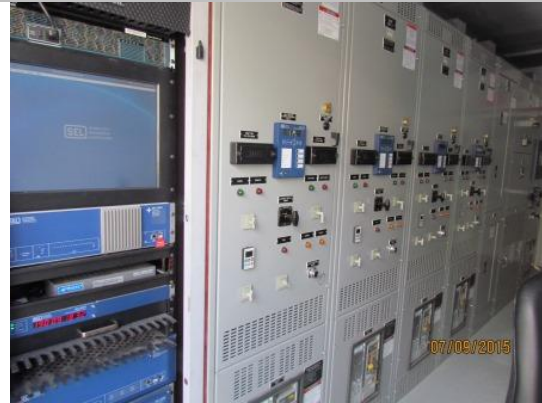
Photo 1 of 1 : ST_2015_NA0060_23_11_20150720_00017.jpg

LM Start	0.00	Rating **	A	Issue No.	11
LM End	0.00	Issue Type +	Ma	Location *	
Category	Pump Stations	GPS Latitude/Longitude			
		Start	End		
Item	Pump Control Systems	39.120096 °		39.120096 °	
		-121.779230 °		-121.779230 °	
DWR ID	DWR_NA0060_23_t_2012_11				
Action/Comments					
Inspector Comments: Pump control systems on site are new and appear to be in working order.

View of the pump computer and control panels

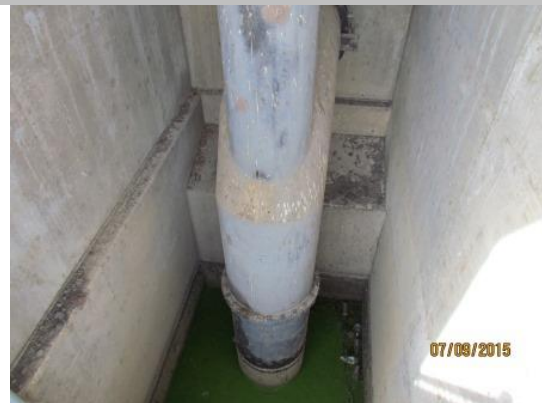
Photo 1 of 2 : ST_2015_NA0060_23_12_20150720_00018.jpg

LM Start	0.00	Rating **	A	Issue No.	12
LM End	0.00	Issue Type +	Ma	Location *	
Category	Pump Stations			GPS Latitude/Longitude	
				Start	End
Item	Sumps/Wet Well			39.120096 °	39.120096 °
				-121.779230 °	-121.779230 °
DWR ID	DWR_NA0060_23_t_2012_12				
Action/Comments					
Inspector Comments: Sumps are clear and free of debris.

View of the wet well.

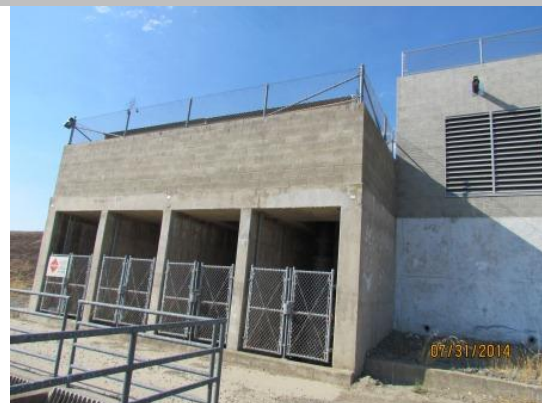
Photo 2 of 2 : ST_2015_NA0060_23_12_20150709_00007.jpg

LM Start	0.00	Rating **	A	Issue No.	12 (cont)
LM End	0.00	Issue Type +	Ma	Location *

View of the wet wells with controlled access.

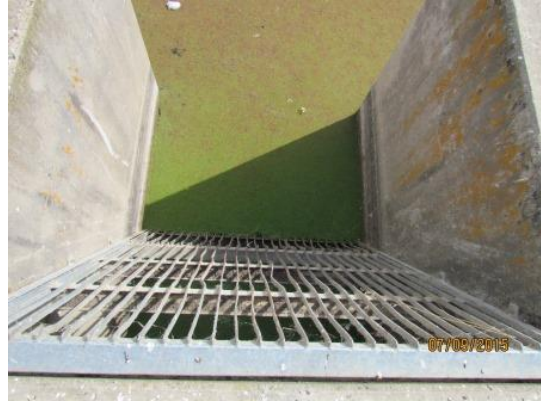
Photo 1 of 1 : ST_2015_NA0060_23_13_20150720_00019.jpg

LM Start	0.00	Rating **	A	Issue No.	13
LM End	0.00	Issue Type +	Ma	Location *	
Category	Pump Stations			GPS Latitude/Longitude	
				Start	End
Item	Trash Racks			39.120096 °	39.120096 °
				-121.779230 °	-121.779230 °
DWR ID	DWR_NA0060_23_t_2012_13				
Action/Comments					
Inspector Comments: No debris present on trash racks, they appear to be in good condition.

View of the trash rack free of debris, total of four similar racks.

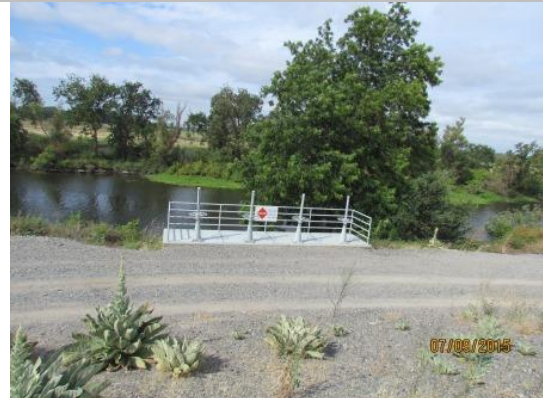
Photo 1 of 1 : ST_2015_NA0060_23_17_20150720_00020.jpg

LM Start	0.00	Rating **	A	Issue No.	17
LM End	0.00	Issue Type +	Ma	Location *	
Category	Pump Stations			GPS Latitude/Longitude	
				Start	End
Item	Manual Gate Operators			39.120096 °	39.120096 °
				-121.779230 °	-121.779230 °
DWR ID	DWR_NA0060_23_t_2012_17				
Action/Comments					
Inspector Comments: Manual gate operators appear to be in good working condition.

Photo shows manual gate operators.

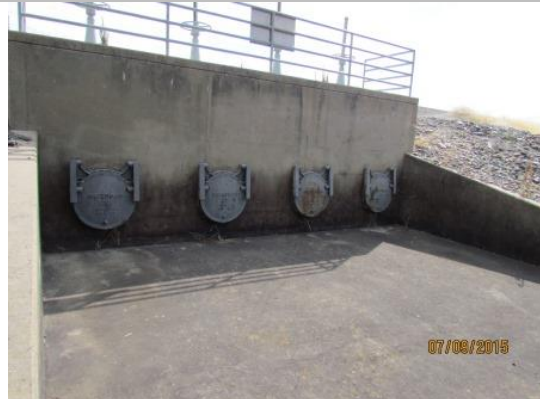
Photo 1 of 1 : ST_2015_NA0060_23_19_20150720_00021.jpg

LM Start	0.00	Rating **	A	Issue No.	19
LM End	0.00	Issue Type +	Ma	Location *	
Category	Pump Stations			GPS Latitude/Longitude	
				Start	End
Item	Flap Gates			39.120096 °	39.120096 °
				-121.779230 °	-121.779230 °
DWR ID	DWR_NA0060_23_t_2012_19				
Action/Comments					
Inspector Comments: Flap gates appear to be in proper working condition, they show no signs of corrosion or damage.

Photo shows flap gates and concrete outfall structure.

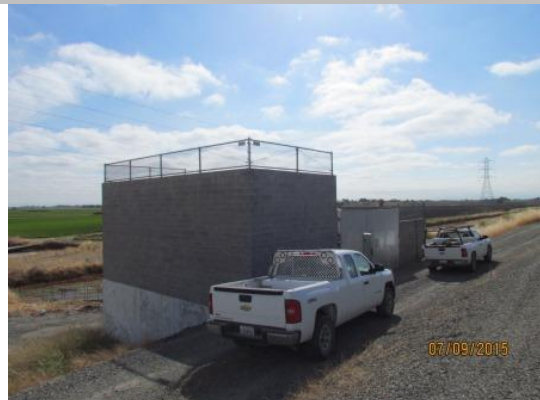
Photo 1 of 1 : ST_2015_NA0060_23_21_20150720_00022.jpg

LM Start	0.00	Rating **	A	Issue No.	21
LM End	0.00	Issue Type +	Ma	Location *	
Category	Pump Stations			GPS Latitude/Longitude	
				Start	End
Item	Security Fencing			39.120096 °	39.120096 °
				-121.779230 °	-121.779230 °
DWR ID	DWR_NA0060_23_t_2012_21				
Action/Comments					
Inspector Comments: Site is currently secured by a masonry brick wall.

Photo shows masonry brick wall which encloses the entire structure.

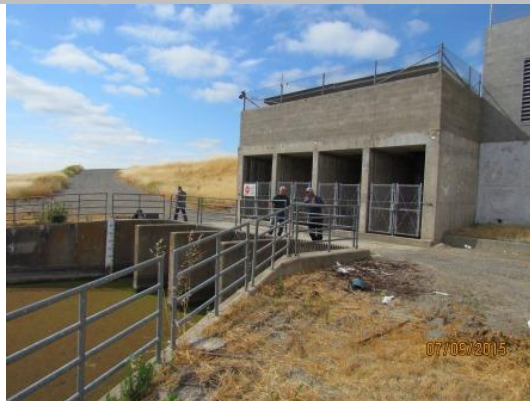
Photo 1 of 1 : ST_2015_NA0060_23_22_20150720_00023.jpg

LM Start	0.00	Rating **	A	Issue No.	22
LM End	0.00	Issue Type +	Ma	Location *	
Category	Pump Stations			GPS Latitude/Longitude	
				Start	End
Item	Intake and Discharge Pipes			39.120096 °	39.120096 °
				-121.779230 °	-121.779230 °
DWR ID	DWR_NA0060_23_t_2012_22				
Action/Comments					
Inspector Comments: No visible deficiencies observed in the pipe's condition.

View of the structure intake.

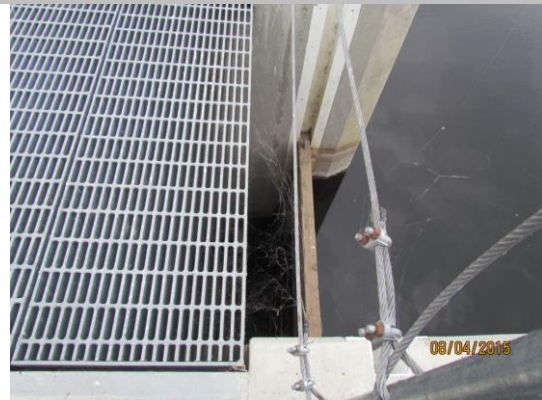
Photo 1 of 1 : x_2015_NA0060_10_23_20150820_00011.jpg

LM Start	0.00	Rating **	A	Issue No.	23
LM End	0.00	Issue Type +	Ma	Location *	
Category	Structures & Concrete Lined Channels			GPS Latitude/Longitude	
				Start	End
Item	Safety			39.102763 °	39.102763 °
				-121.758738 °	-121.758738 °
DWR ID	DWR_NA0060_10_t_2012_23				
Action/Comments					
Inspector Comments: Safety hardware installed. Adequate protection for fall hazards exist. No hazardous conditions that might affect the operation of the structure.

View of the type of safety railing used on the weir.

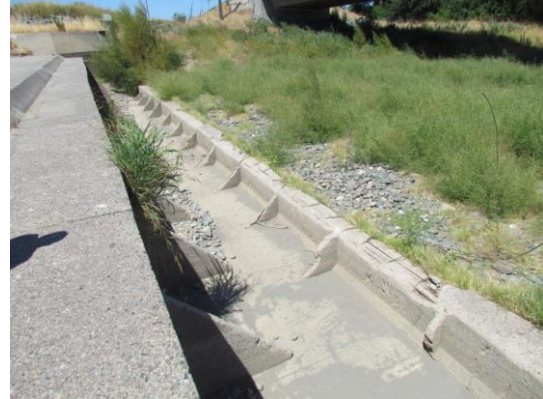
Photo 5 of 6 : ST_2015_NA0060_3_1_20150528_00005.jpg

Exposed rebar with lengths in excess of 6 feet. Should be cut off flush with concrete surface.

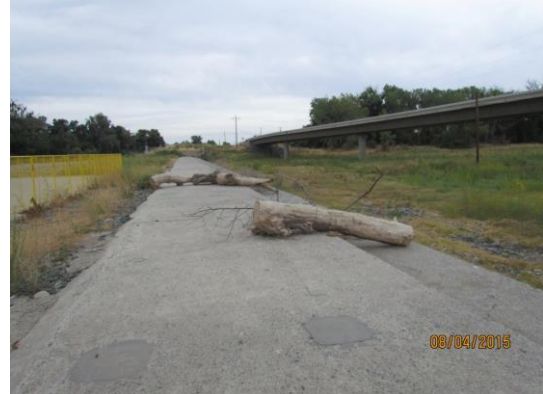
Photo 1 of 2 : x_2015_NA0060_3_2_20150820_00015.jpg

LM Start	0.00	Rating **	M	Issue No.	2
LM End	0.00	Issue Type +	Ma	Location *	
Category	Structures & Concrete Lined Channels			GPS Latitude/Longitude	
				Start	End
Item	Vegetation & Obstructions			39.026713 °	39.026713 °
				-121.821995 °	-121.821995 °
DWR ID	DWR_NA0060_3_t_2012_2				
Action/Comments					
Inspector Comments: Minimal, scattered logs in the weir and on the upstream side. The flow is not impeded.

View of the logs found on the weir facing the left bank of the channel.

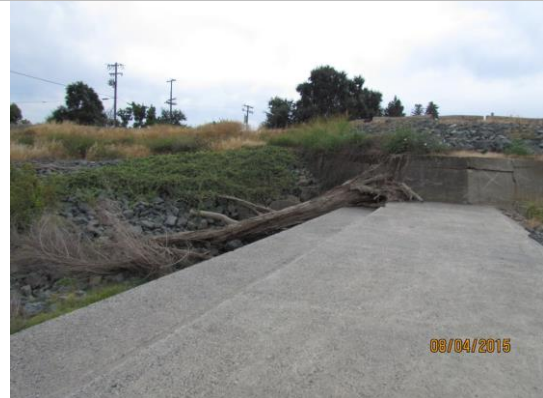
Photo 2 of 2 : x_2015_NA0060_3_2_20150820_00019.jpg

View of a fallen tree that has snagged on the right bank of the weir.

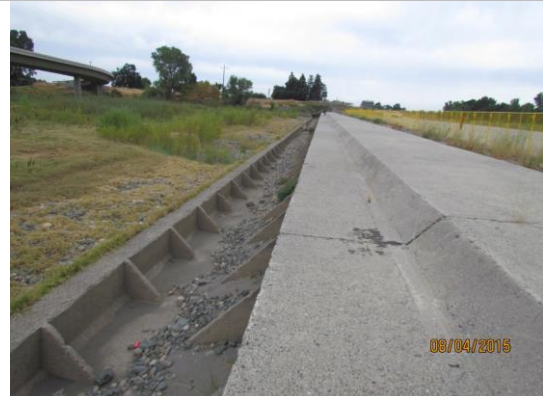
Photo 1 of 2 : x_2015_NA0060_3_3_20150820_00017.jpg

LM Start	0.00	Rating **	A	Issue No.	3
LM End	0.00	Issue Type +	Ma	Location *	
Category	Structures & Concrete Lined Channels			GPS Latitude/Longitude	
				Start	End
Item	Shoaling / Sedimentation			39.026713 °	39.026713 °
				-121.821995 °	-121.821995 °
DWR ID	DWR_NA0060_3_t_2012_3				
Action/Comments					
Inspector Comments: Minimal shoaling or sedimentation present.

View of the sediment buildup in the weir facing the right bank of the channel.

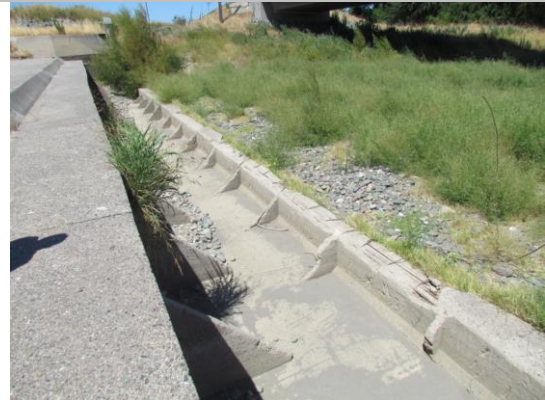
Photo 1 of 1 : x_2015_NA0060_3_23_20150820_00020.jpg

LM Start	0.00	Rating **	A	Issue No.	23
LM End	0.00	Issue Type +	Ma	Location *	
Category	Structures & Concrete Lined Channels			GPS Latitude/Longitude	
				Start	End
Item	Safety			39.026713 °	39.026713 °
				-121.821995 °	-121.821995 °
DWR ID	DWR_NA0060_3_t_2012_23				
Action/Comments					
Inspector Comments: Exposed rebar needs to be cut flush with existing concrete surface.

View of the rebar that is needed to be cut flush on the weir.

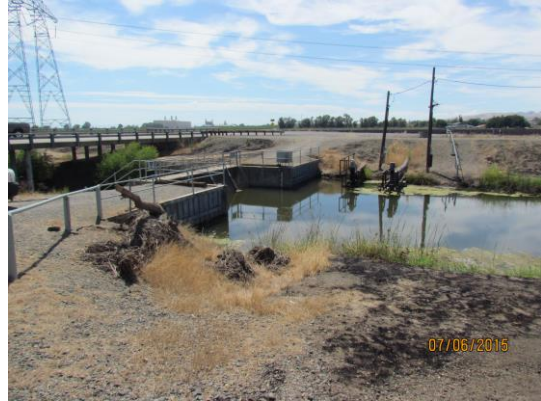
Photo 1 of 1 : ST_2015_NA0060_11_23_20150723_00004.jpg

LM Start	0.00	Rating **	N	Issue No.	23
LM End	0.00	Issue Type +	Ma	Location *	
Category	Structures & Concrete Lined Channels			GPS Latitude/Longitude	
				Start	End
Item	Photo Documentation			39.153325 °	39.153325 °
				-121.734122 °	-121.734122 °
DWR ID	DWR_NA0060_11_t_2012_23				
Action/Comments					
Inspector Comments: Upstream side of the structure is clear of debris.

View of the upstream side of the Wadsworth Canal Weir No. 4.

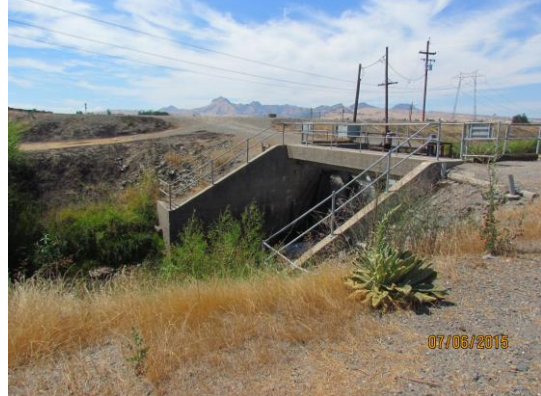
Photo 1 of 1 : ST_2015_NA0060_11_3_20150723_00003.jpg

View of the downstream side of the Wadsworth Canal Weir No.4 showing erosion along channel.

LM Start	0.00	Rating **	M	Issue No.	3
LM End	0.00	Issue Type +	Ma	Location *	
Category	Structures & Concrete Lined Channels			GPS Latitude/Longitude	
				Start	End
Item	Erosion / Bank Caving			39.153325 °	39.153325 °
				-121.734122 °	-121.734122 °
DWR ID	DWR_NA0060_11_t _ 2012_3				
Action/Comments					
Inspector Comments: Repair all erosion along the channel before winter.
